## **Merkel & Associates, Inc.**

July 12, 2011  
M&A # 05-024-20

### **Re: FINAL 6-month Eelgrass Monitoring Report for the Morro Bay Maintenance Dredging Project, Morro Bay, CA (#W912PL-10-F-0003 Task 8[h])**

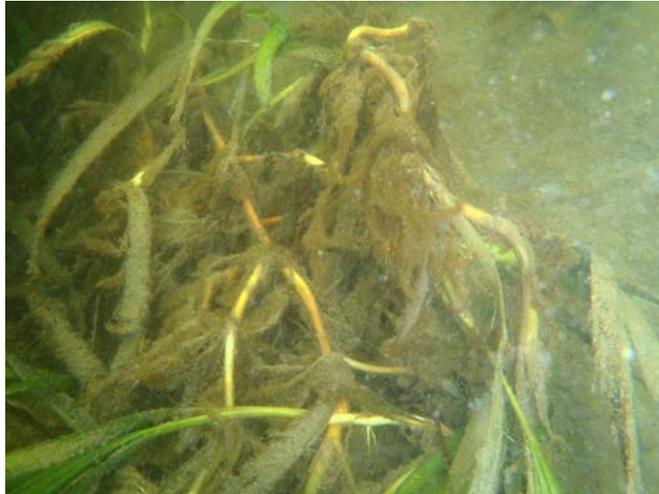
The mitigation site, like the entirety of the bay, was affected by the tsunami that followed the March 11, 2011 Japanese earthquake. Staff at the Morro Bay Harbor Department reported water level swings of up to 9 feet over periods of approximately 15 minutes. They also reported seeing water flowing off of eelgrass beds into the channel as if the beds were located on the crest of a weir. Following the tsunami, Annie Gillespie of the Morro Bay National Estuary Program (NEP) reported observing considerable eelgrass floating free on the surface of the bay, apparently washed out of the sediment. Loose rhizomes were detected at the bayward edge of the A-1 Anchorage Reference Site, however, overall neither reference areas nor the transplant area appear to have suffered widespread tsunami damage. Within the transplant area, a small sand chute developed off the planting area near the center of the site. This chute cuts slightly into the developing eelgrass beds and likely was the result of concentrated discharge across the site during the tsunami. Because this chute is found at the lowest portion of the site and is not expected to experience comparable energy as that occurring during the 2011 tsunami, there is little reason to believe it will have any long-term adverse effects on the site.

*Rhizomes freed from sediment near the edge of eelgrass beds at the A-1 Anchorage Reference Site*

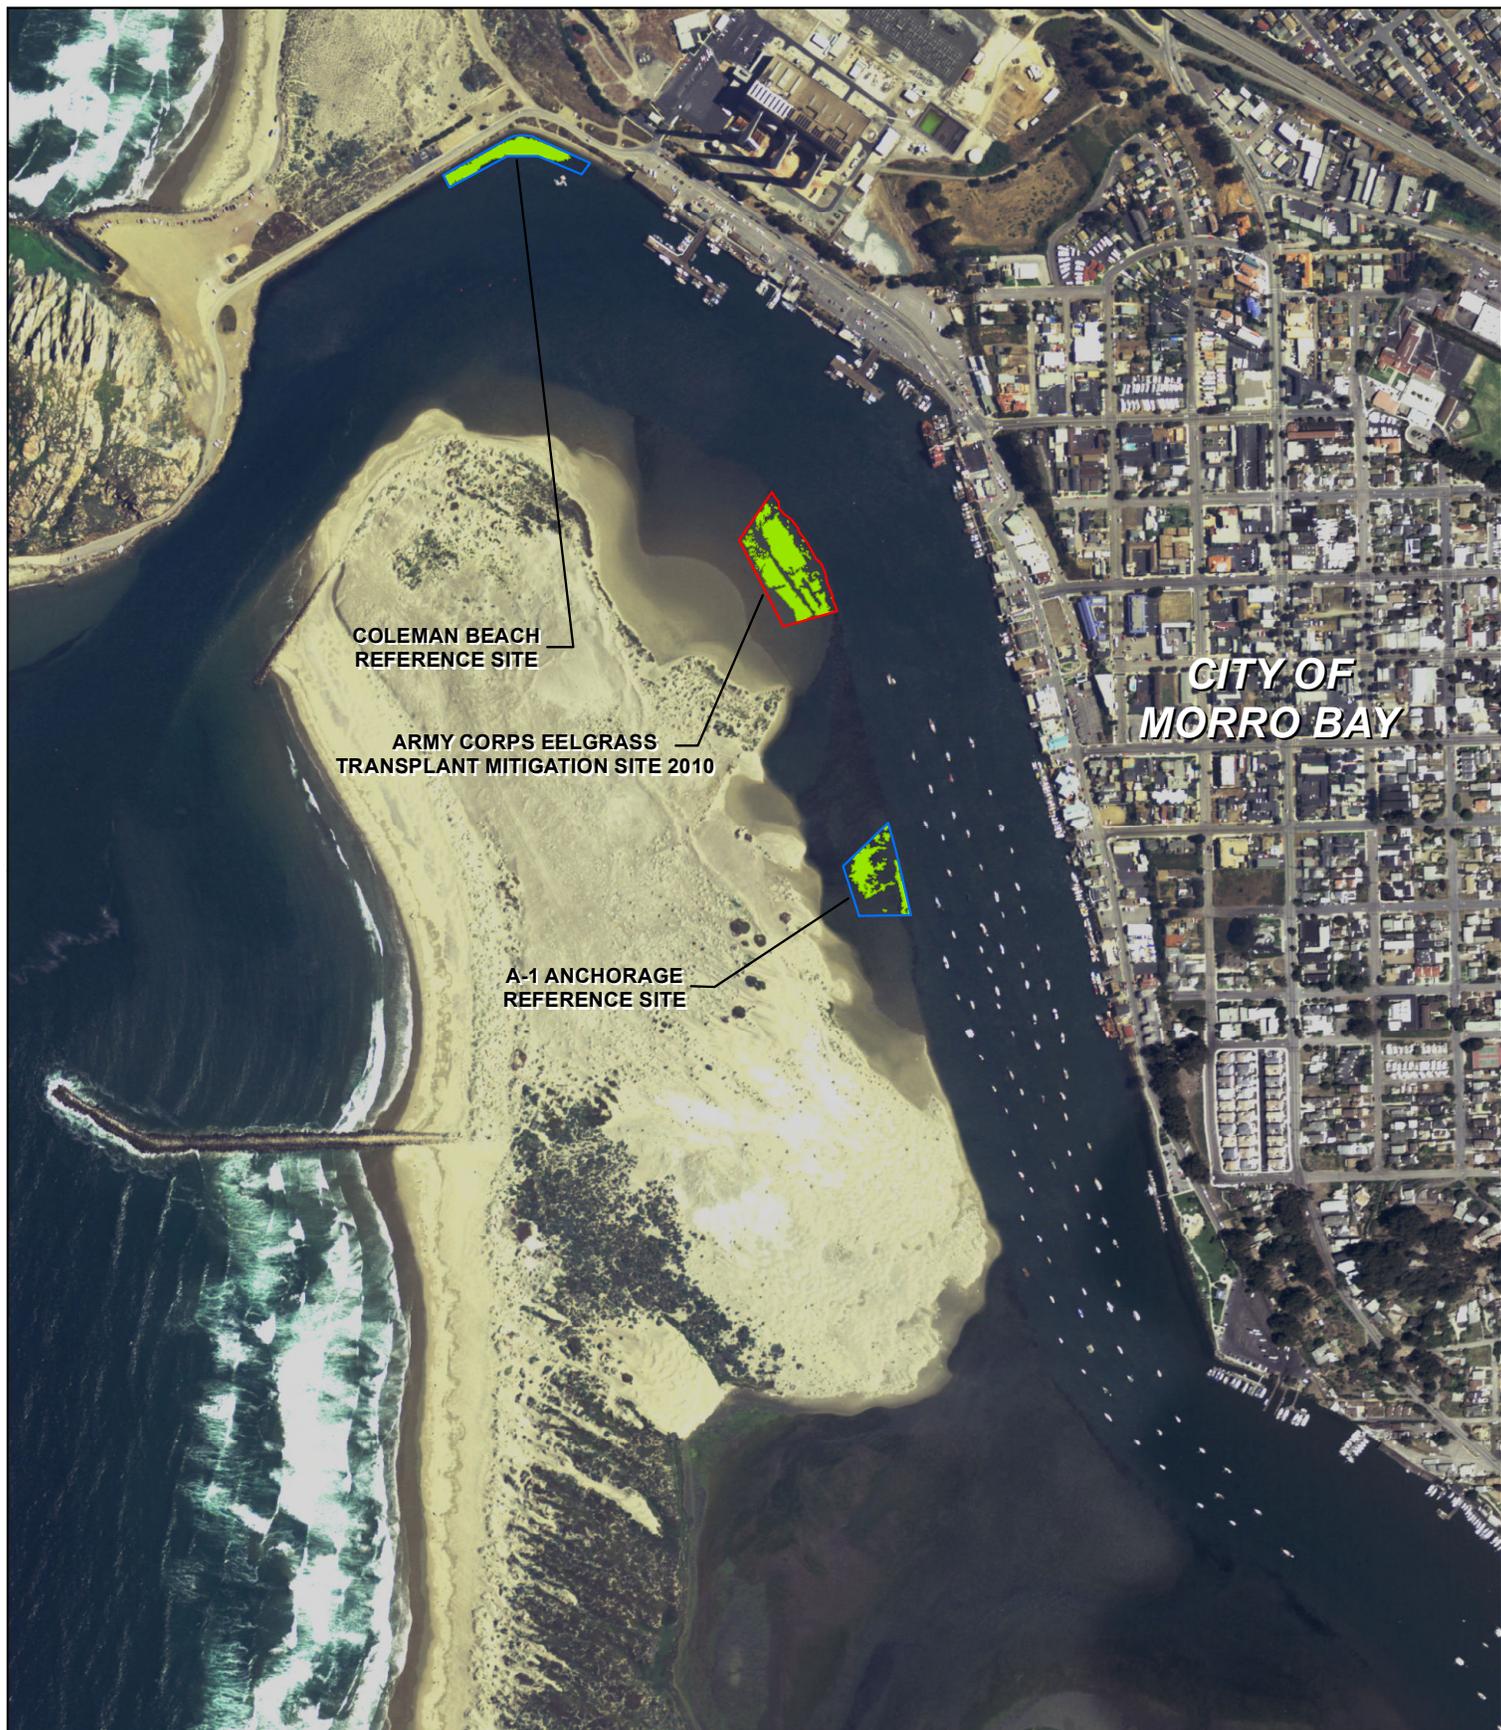
**Figure 3**

The current 6-month survey revealed a total of 1.3 acres (5,340 m<sup>2</sup>) of eelgrass planting units within the transplant area (Figure 3). By the 3-month post-transplant survey (October 2010), plants in the

**Eelgrass Distribution, April 17 2011**  
Morro Bay Maintenance Dredging Project  
Morro Bay, CA

low-density transplant areas had not expanded substantially from the initial transplant size. At the 6-month survey, plants showed significant increase in size, however individual transplant units generally remained distinguishable from acoustic records. The initial beds planted at 1-meter centers had coalesced to solid eelgrass beds while the more widely distributed plantings at 3-meter centers remained incomplete but expanding by vegetative spread by individual units. No seedling recruitment was observed at the 6-month survey period. At the present time, it appears that most of the initial planting site remains suitable to support eelgrass. There has been some loss of eelgrass at the uppermost portions of the initially constructed site; however, most of the site appear to be fairly stable and is expected to remain suited to support eelgrass.

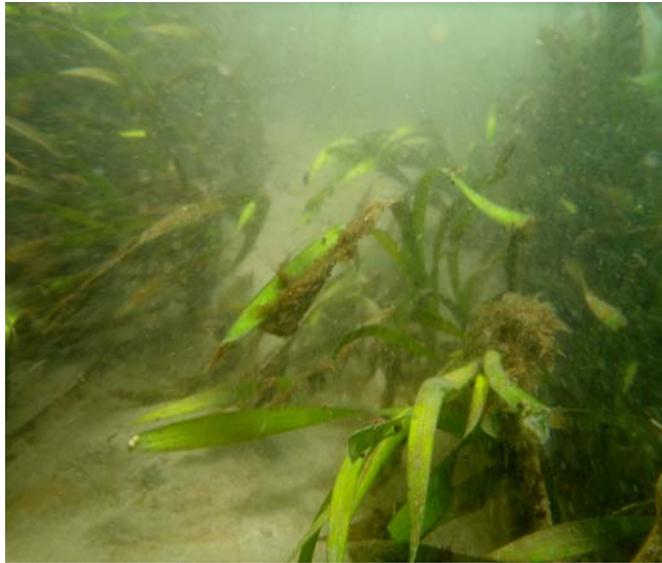
Eelgrass patches in the Army Corps mitigation site

The eelgrass turion density ( $\pm 1$  SD) within the transplant area was  $134.4 \pm 40.3$  ( $n=20$ ) shoots per square meter. Eelgrass was generally healthy and supported moderate epiphytic loading.
